Tacho Universal Hand-Held Repair Update Manual

2 Repair TACHO Universal Hand-Held Device

3 Update TACHO Universal Hand-Held Device

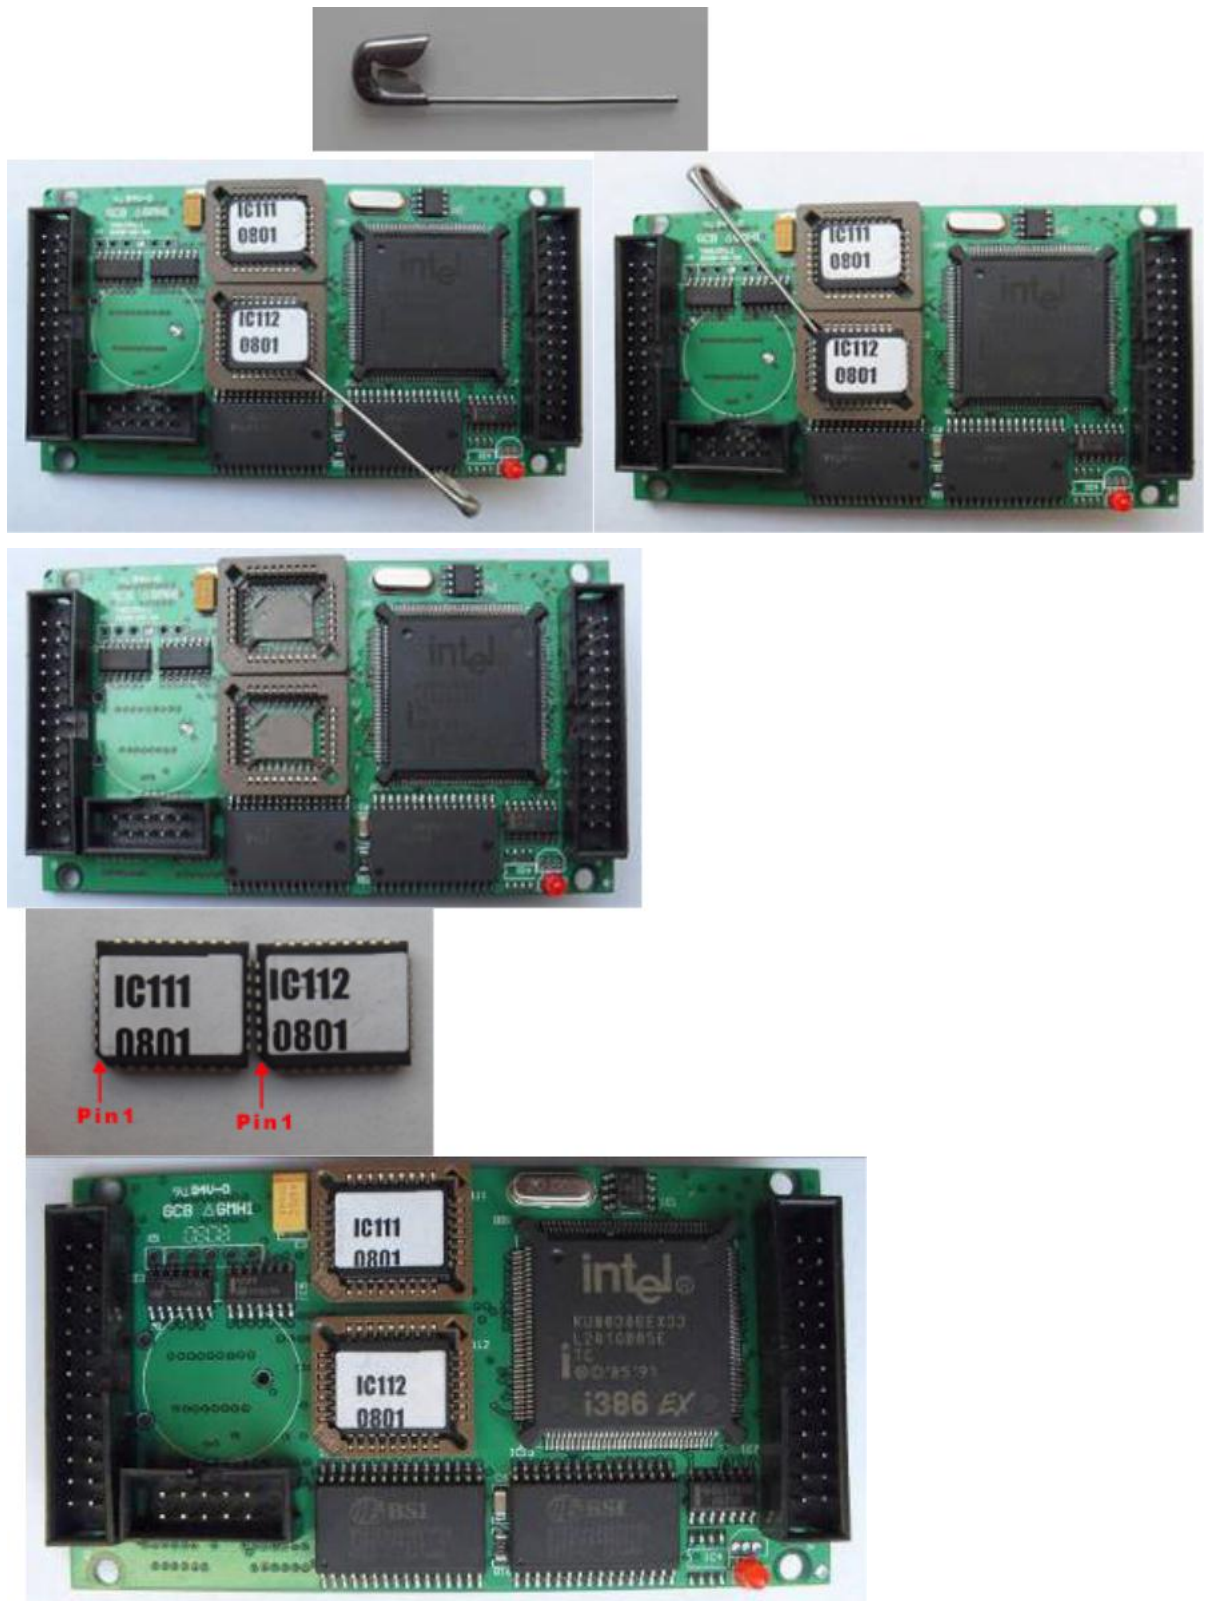
2.2.1 Replace IC111 and IC112 as shown in the figure.

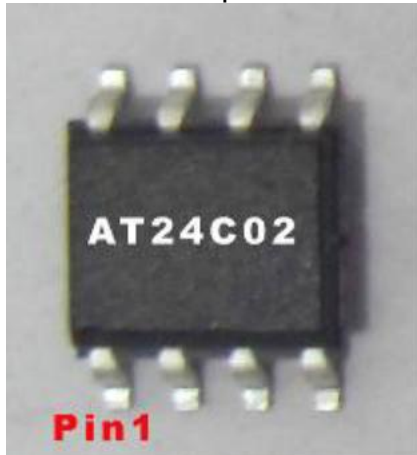
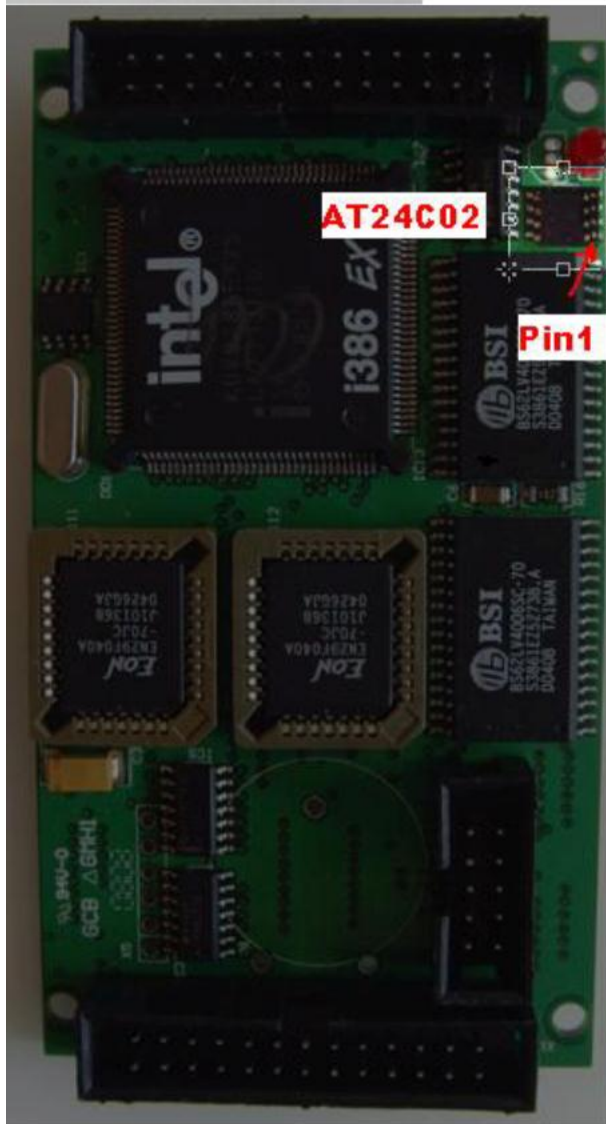
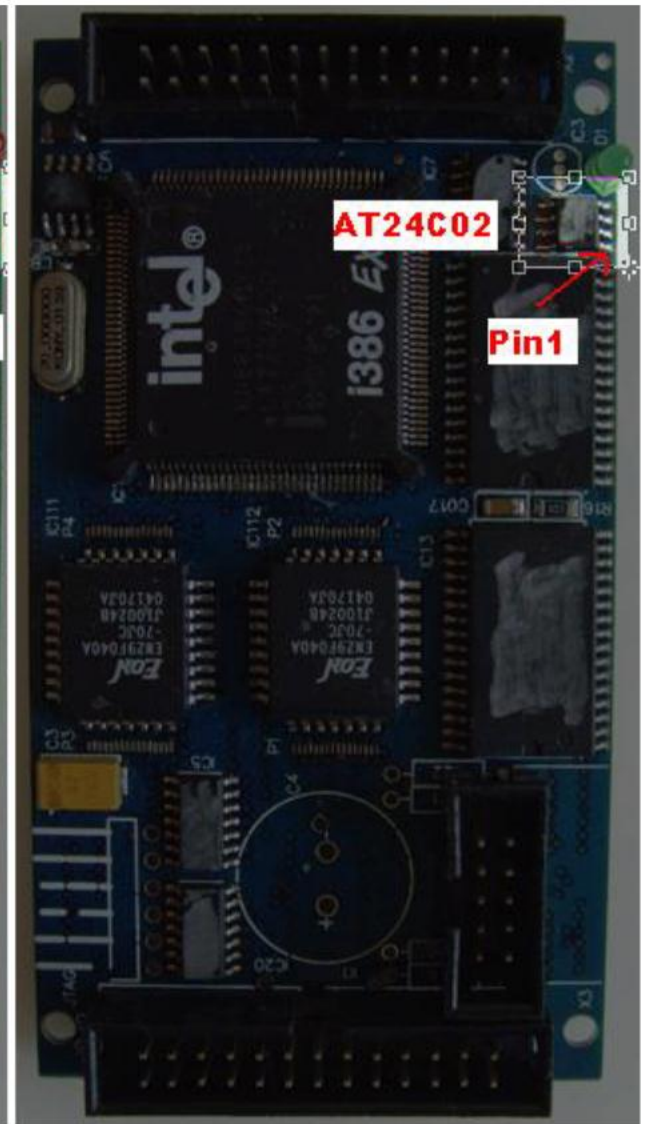
2.2.2 Replace AT24C02 as shown in the figure.

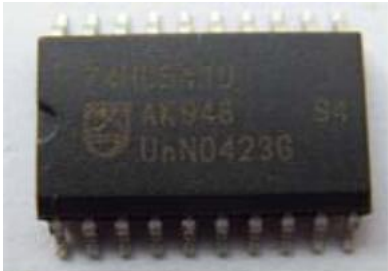
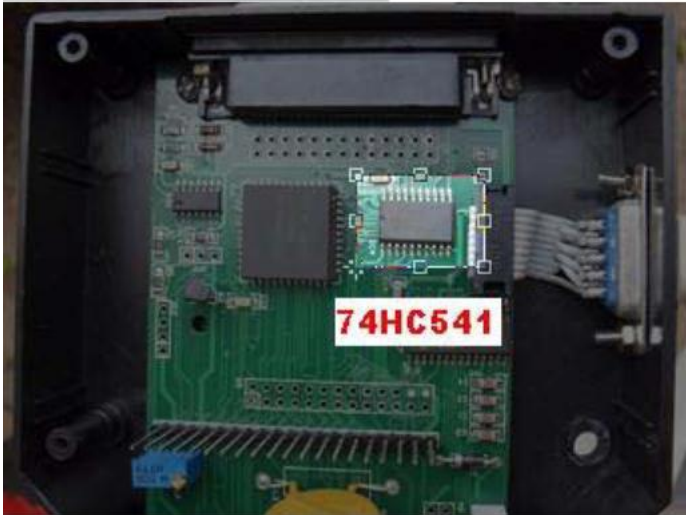
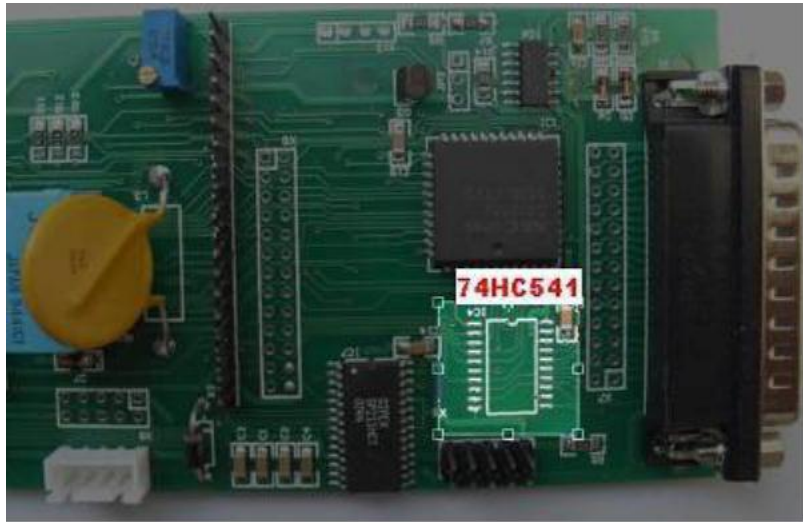
2.2.3 Replace 74HC541

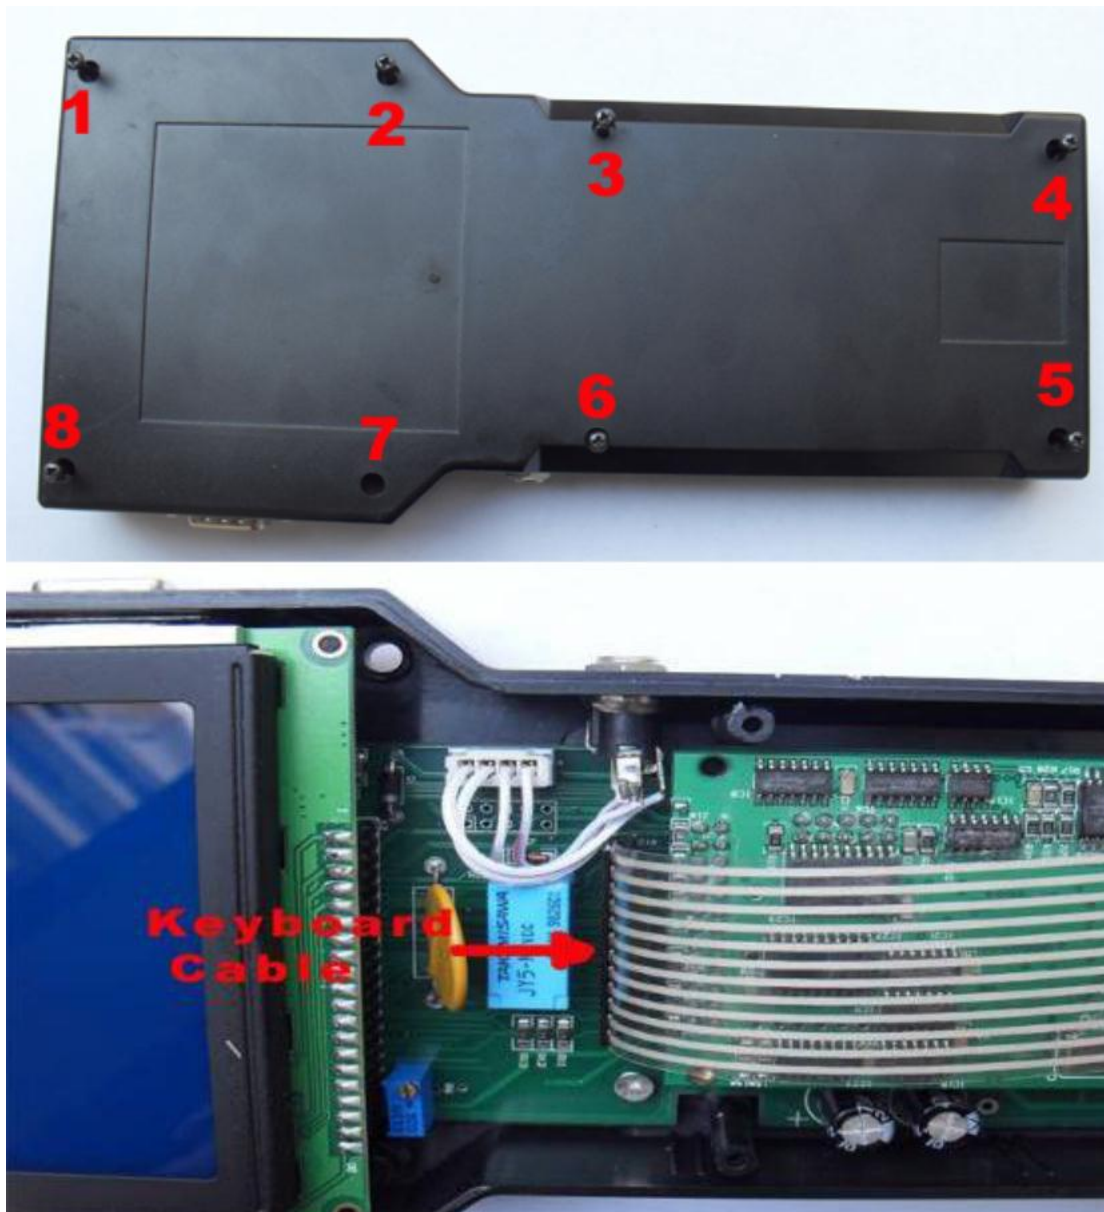
3.1 Remove the 8 screws, open the up cover, unplug the keyboard cable connector, and then remove the up cover as shown in the figure.

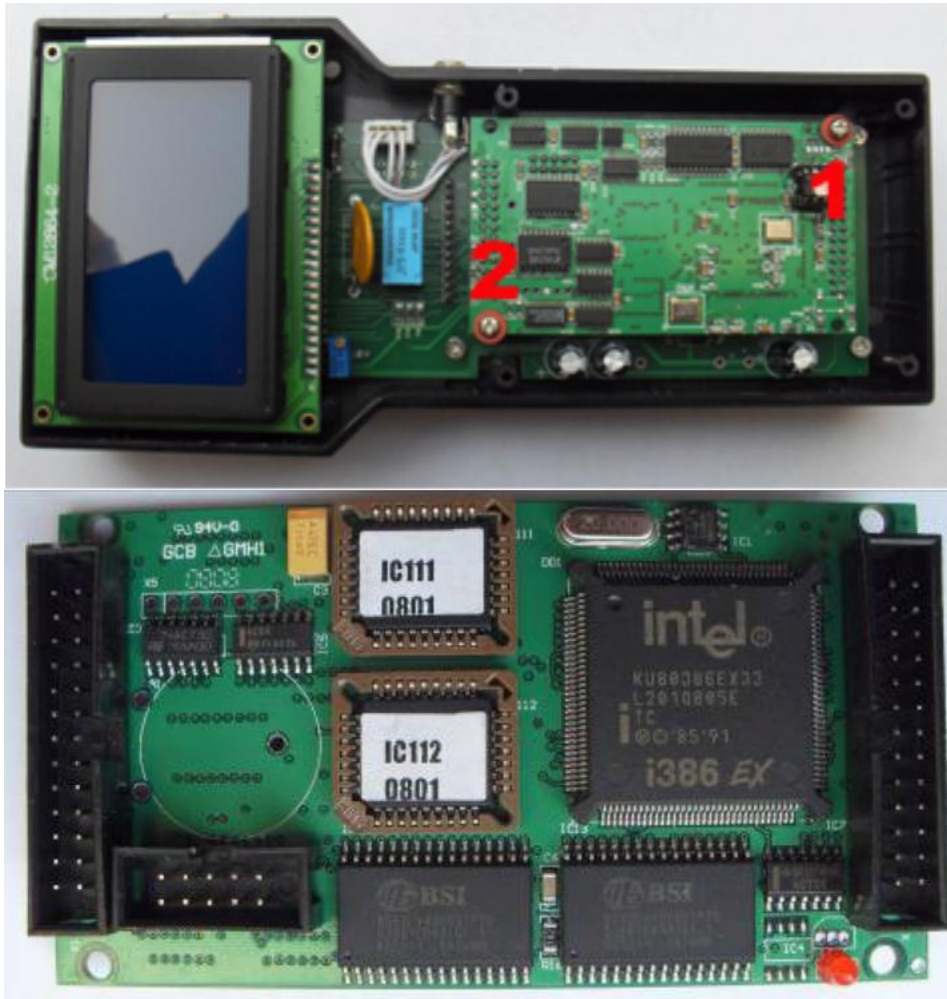
3.2 Remove the CPU BOARD as shown in the figure.

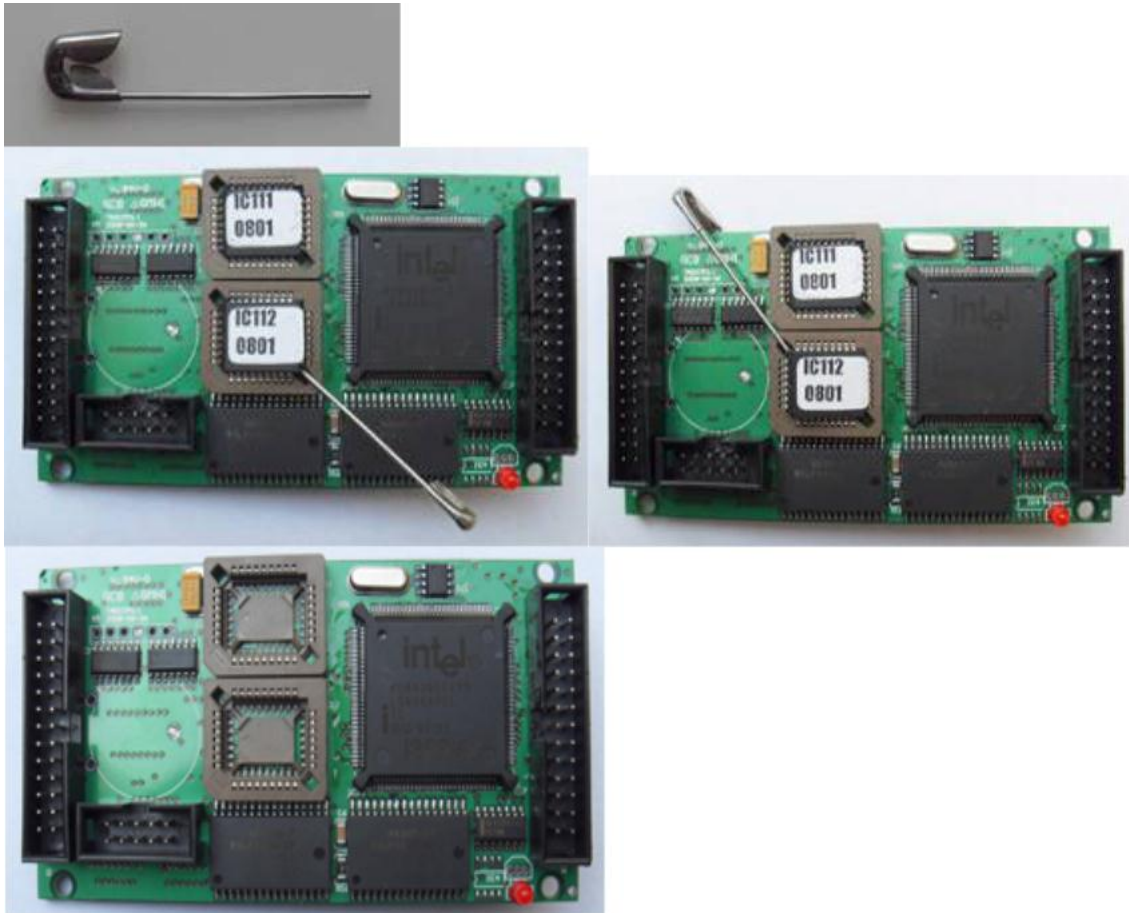
3.3 Remove IC111 and IC112 as shown in the figure.

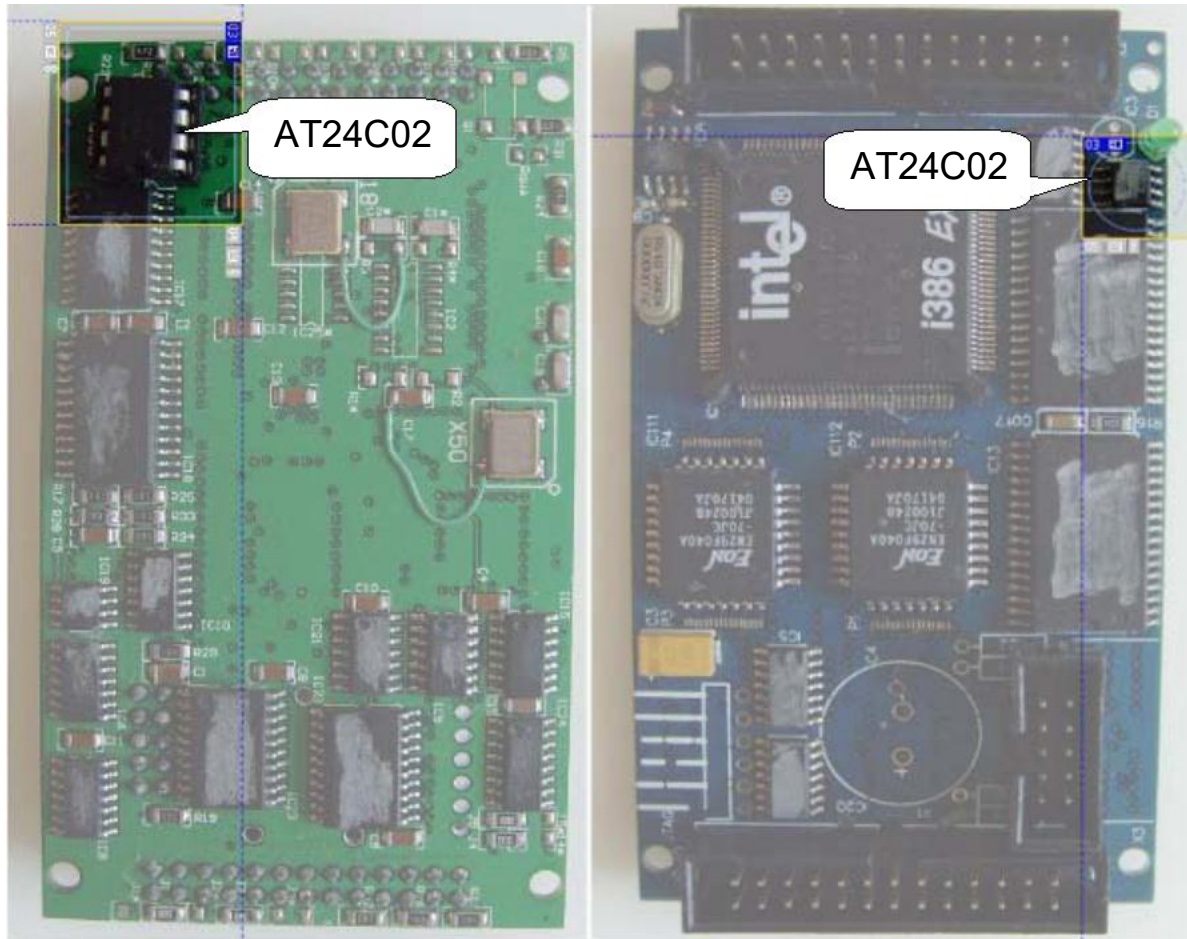
3.4 Remove AT24C02 as shown in the figure.

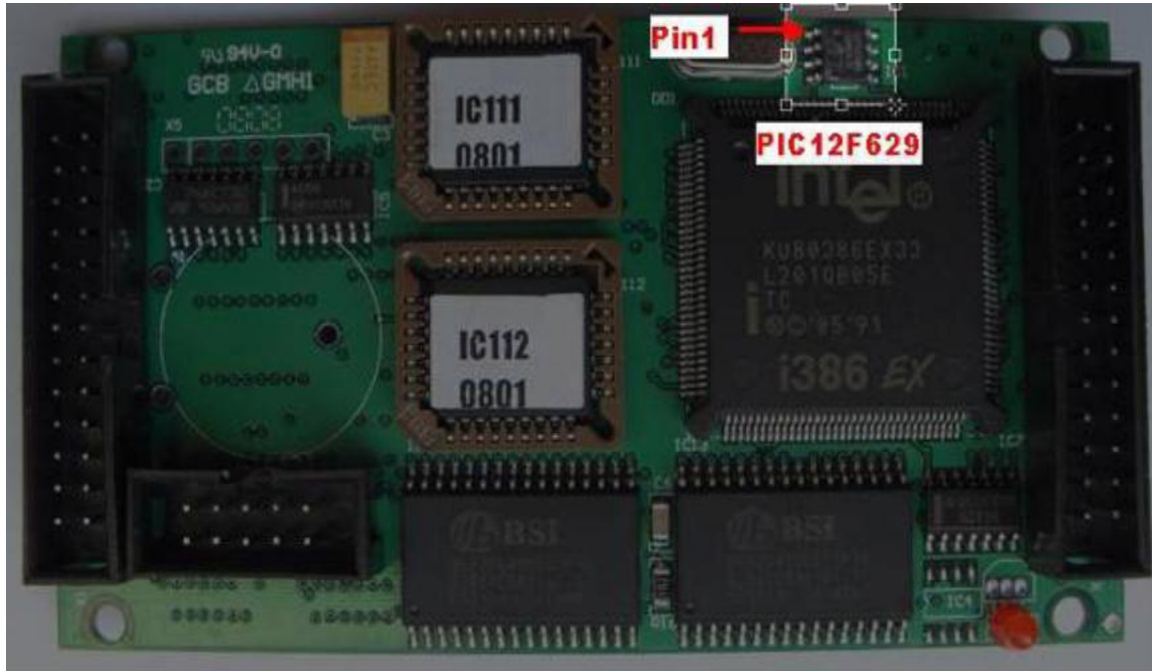
3.5 Remove PIC12F629 as shown in the figure.

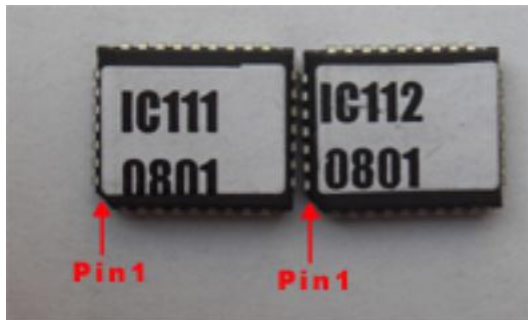
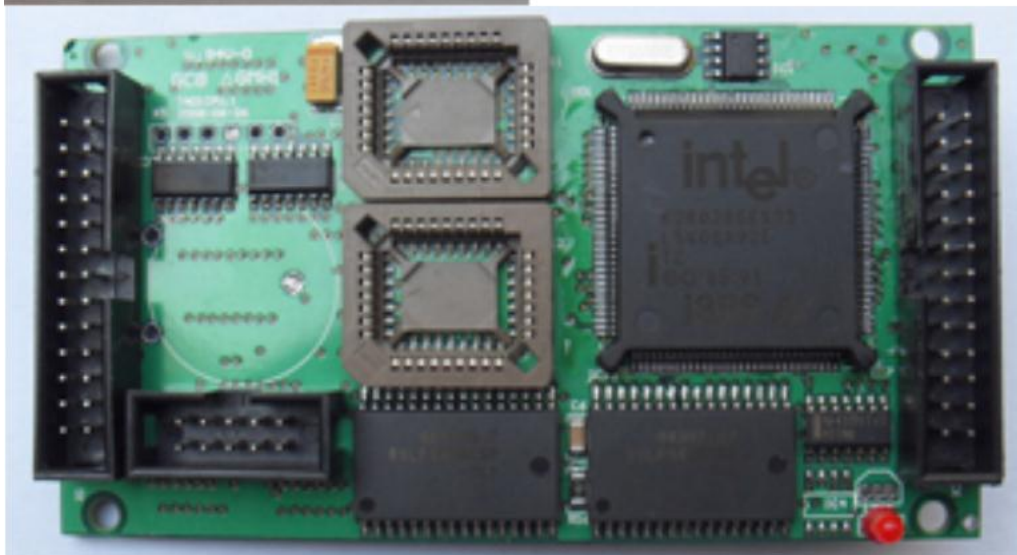
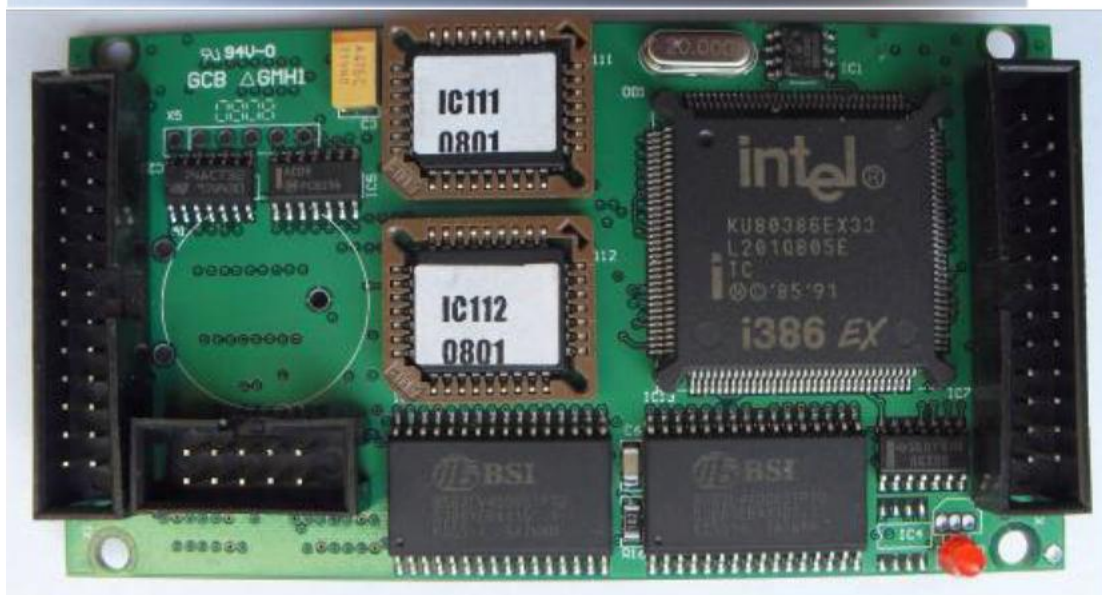
3.6 Install IC111 and IC112. Make sure the install direction is correct. See the figure.

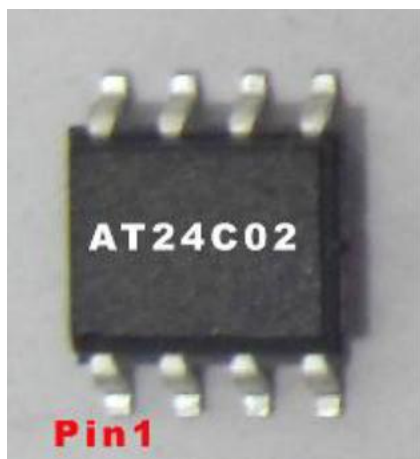
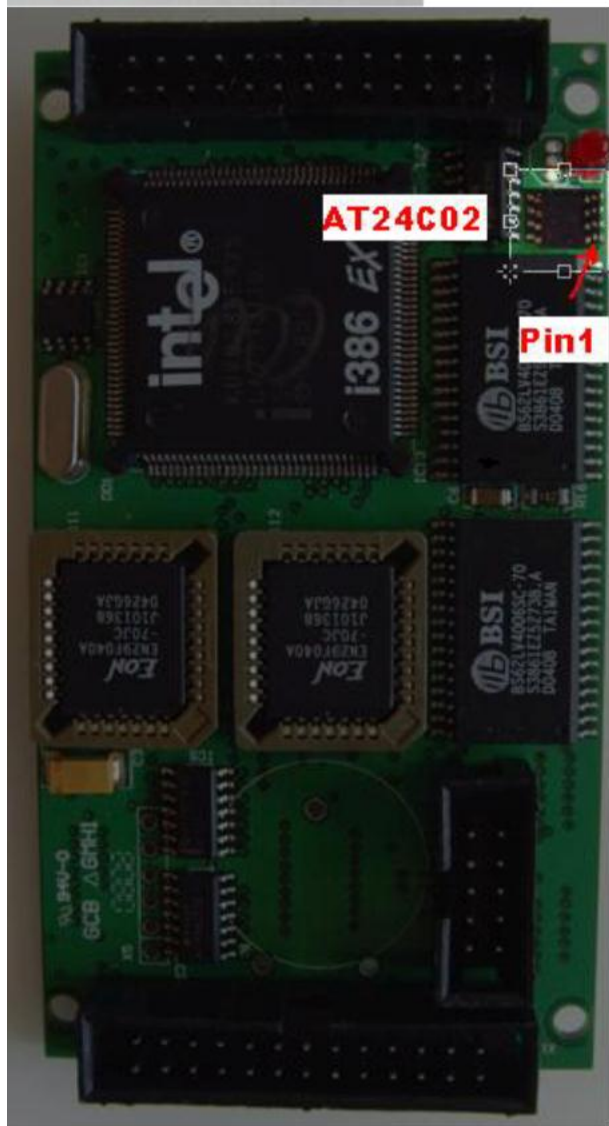
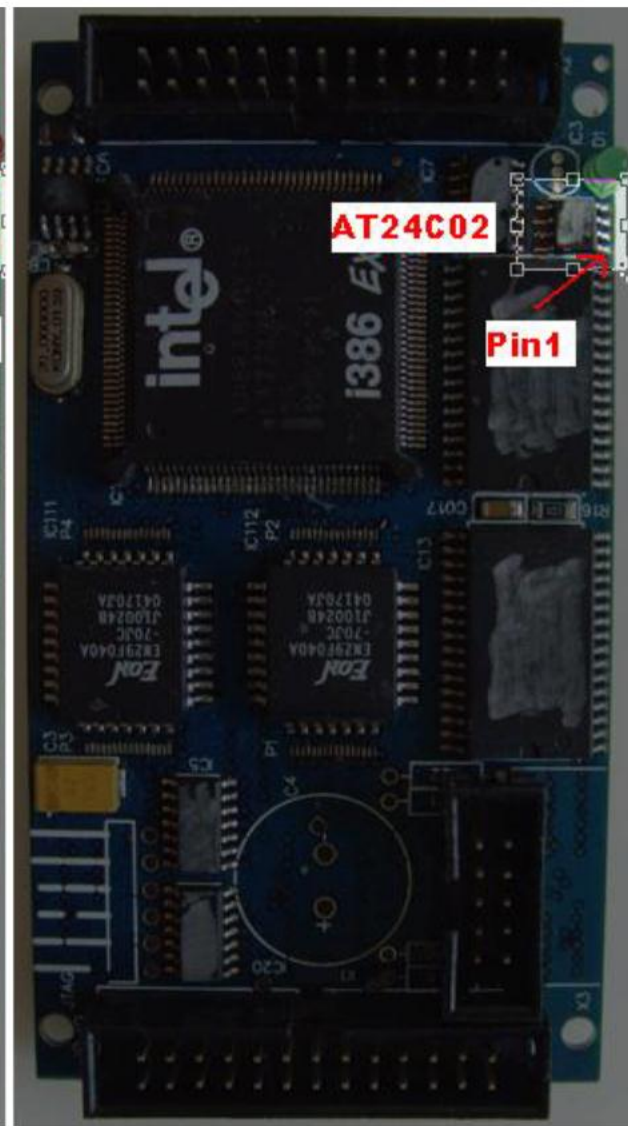
3.7 Install AT24C02. Make sure the install direction is correct.
See the figure.

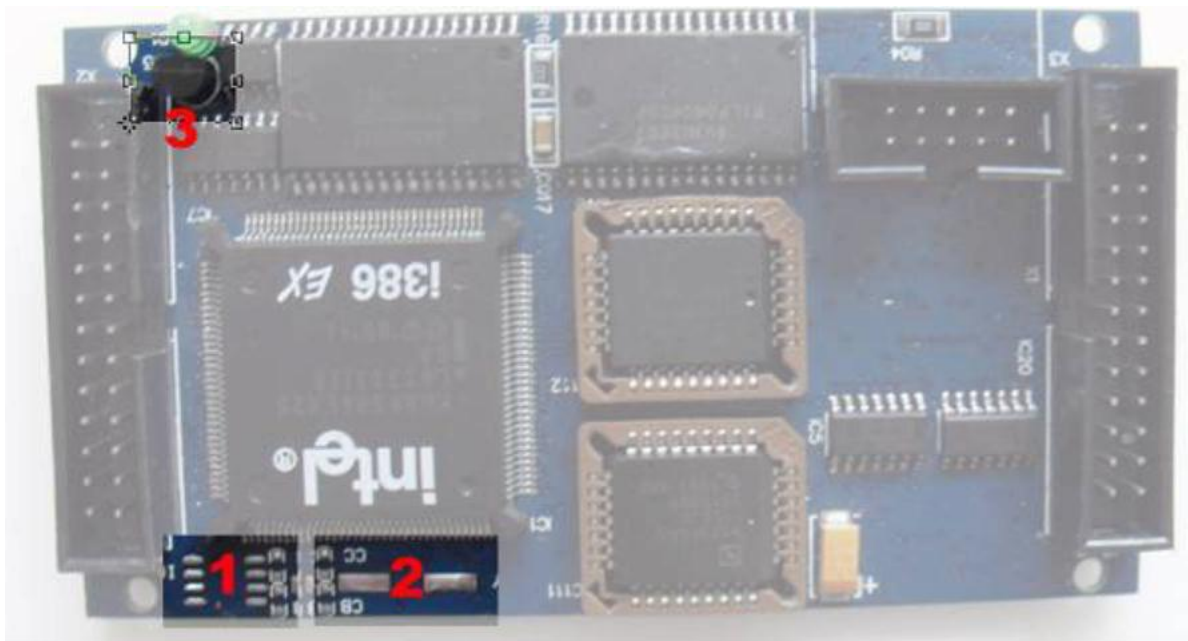
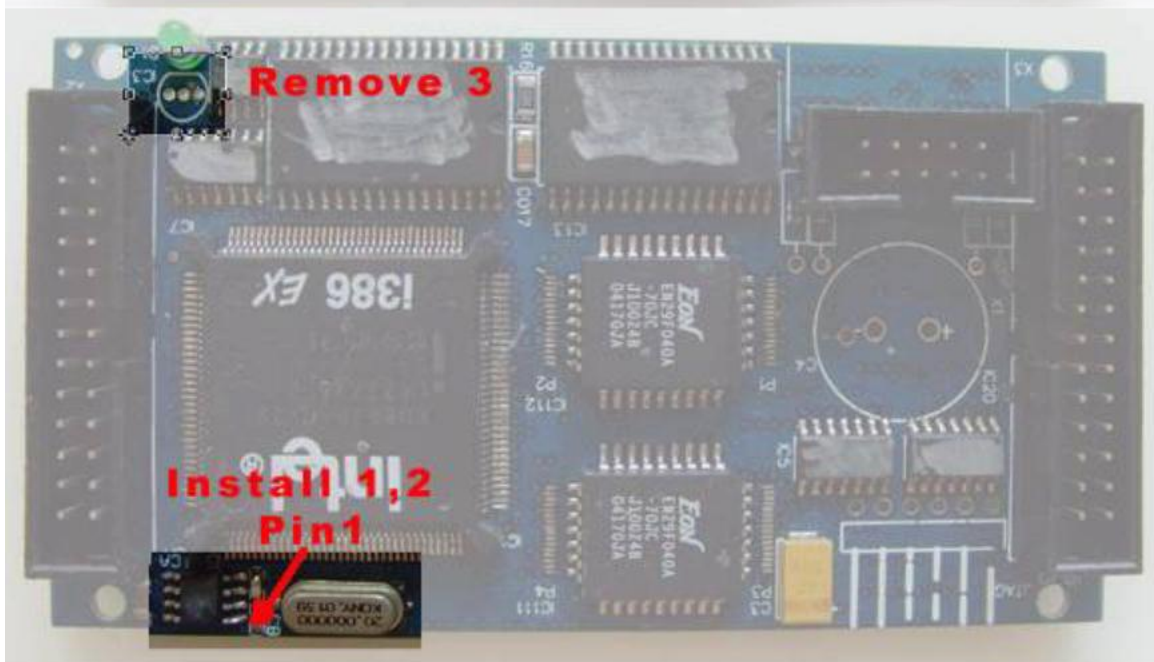
3.8 On your board, if there are not components in position 1 and 2, please remove component in position 3. and then fix PIC12F629 onto the position on 1. fix OSC on the proper position in 2.

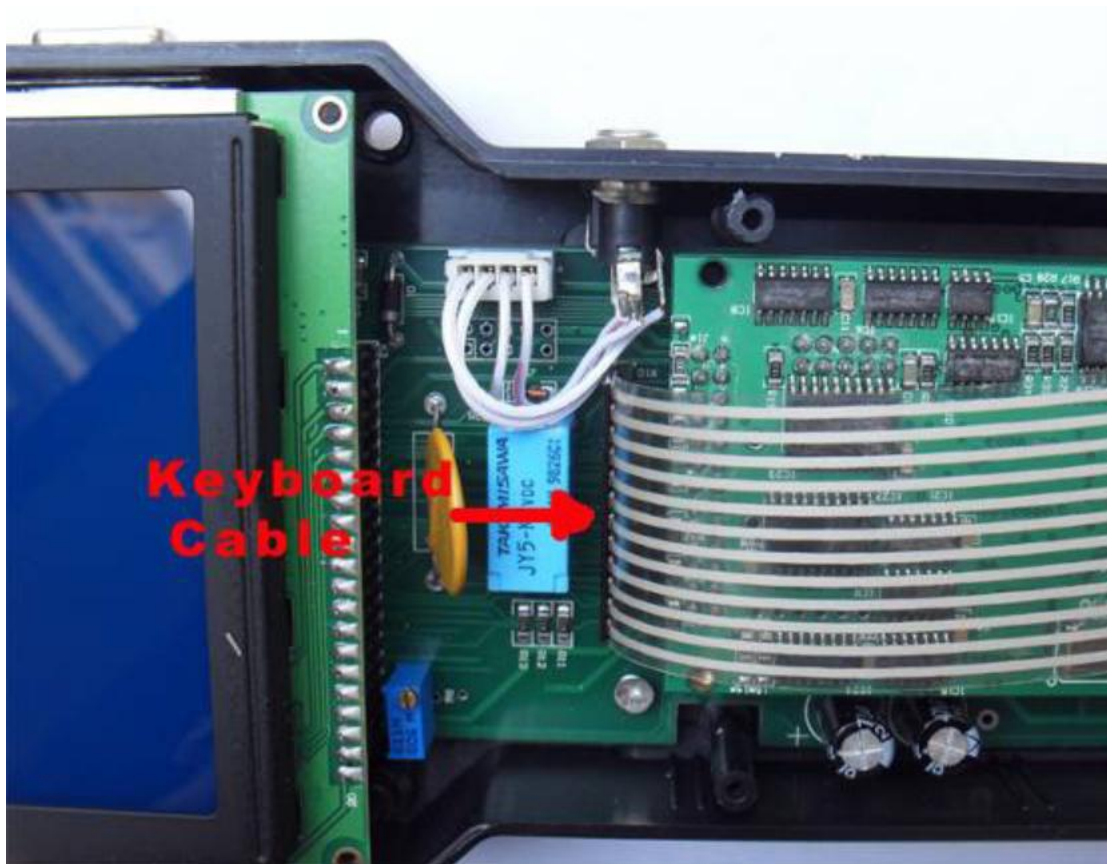
3.9 Install CPU BOARD. Make sure install it in correct direction. See the figure.

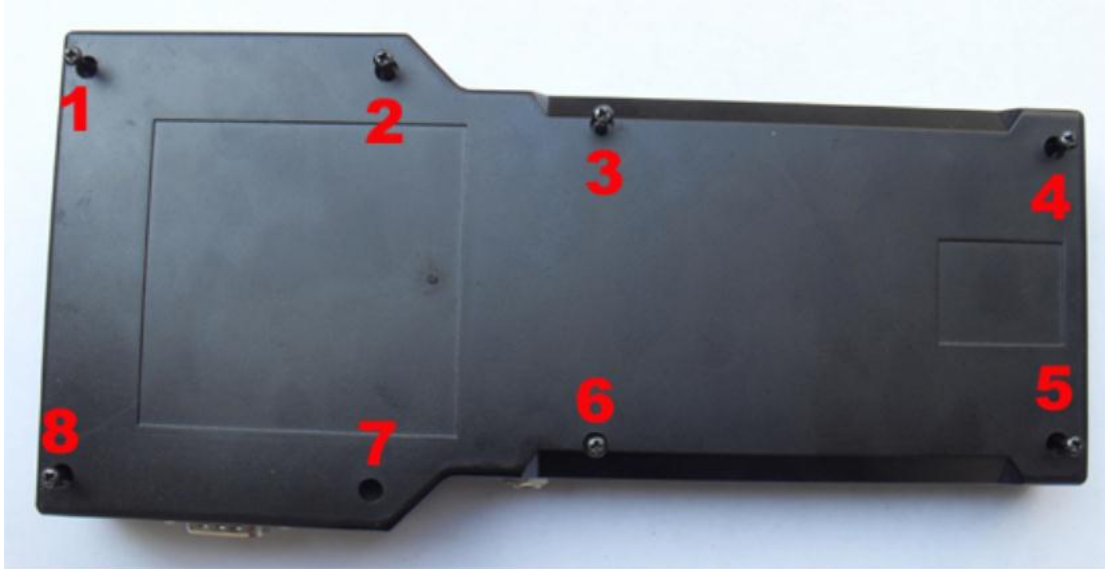
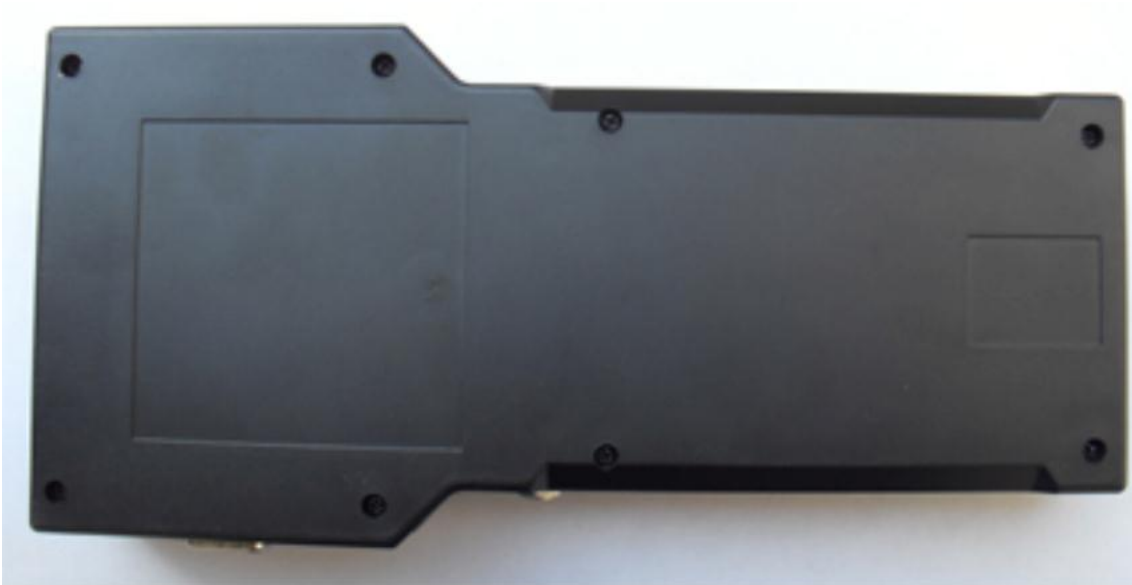
3.13 Install the up cover and then the 8 screws.
See the figure.

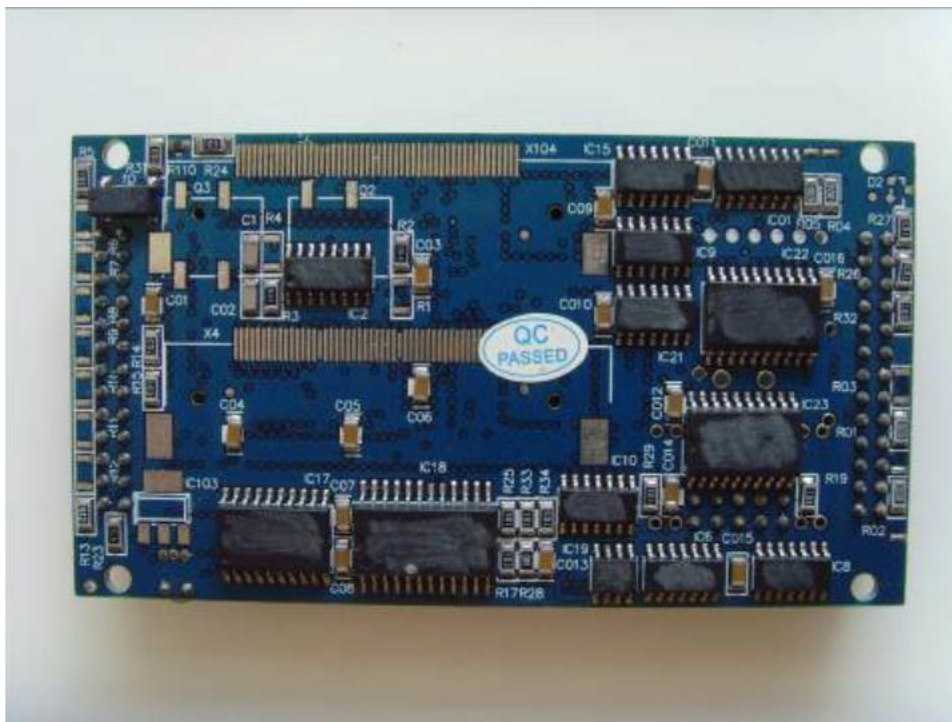
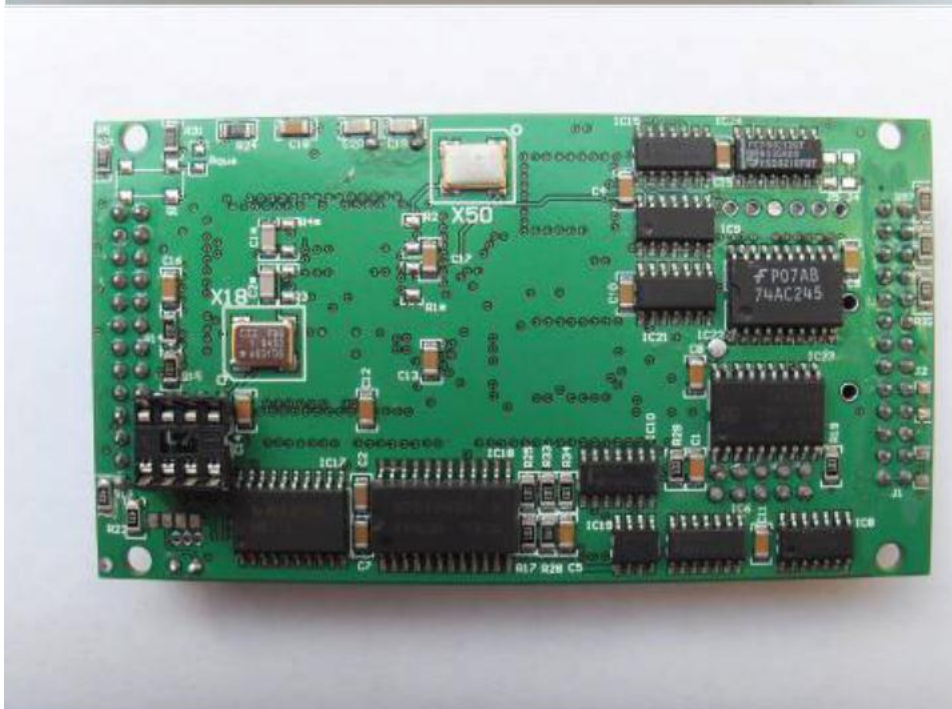
Picture 1

Step 1. Remove the CPU BOARD from TACHOPRO i.e. the principal machine. See picture 1.

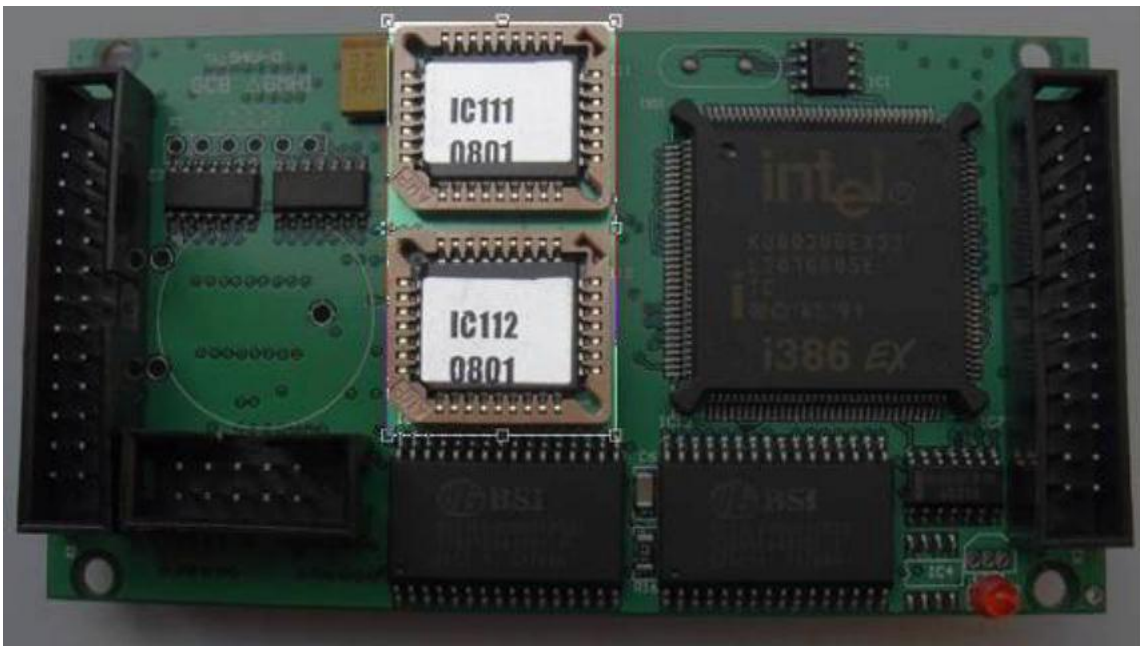
Picture 2

Step 2. Find the location of IC111& IC112 and replace the previous IC on CPU BOARD with the IC111&IC112 of Update Kit. Make sure the IC is properly located with correct direction. See picture 2

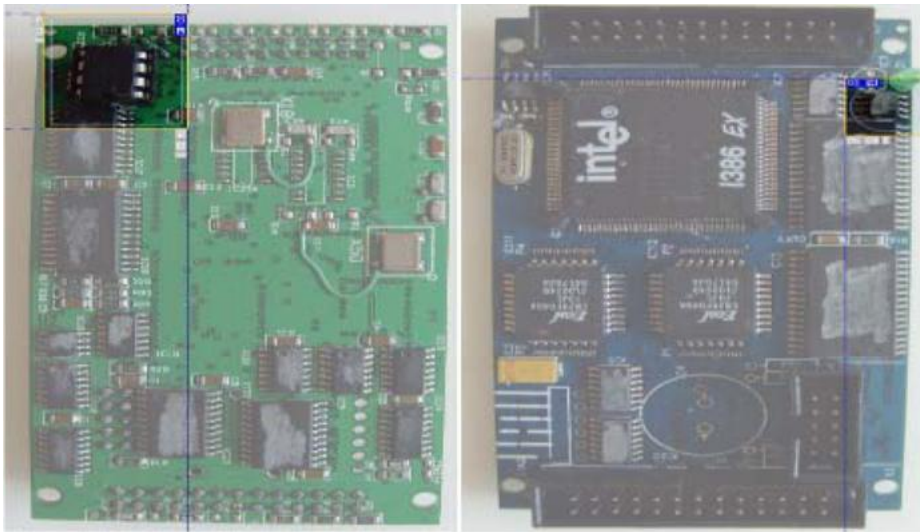
Picture 3A

Step 3. Find AT24C02 on CPU BOARD. Remove the previous IC by using electric iron and then place AT24C02 on the corresponding location to guarantee the direction of IC. See picture 3A, 3B

Note: pay attention to CPU BOARD in picture 3A. First of all, the IC socket should be taken out from AT24C02 and then weld AT20C02 to the specified position in picture 3B.
